Experimental Study of the Durability of Textile Reinforced Cementitious Composites

For Outdoor Applications of Sandwich Panels

Jens De Koster

In order to be awarded the Master's Degree in
Civil Engineering

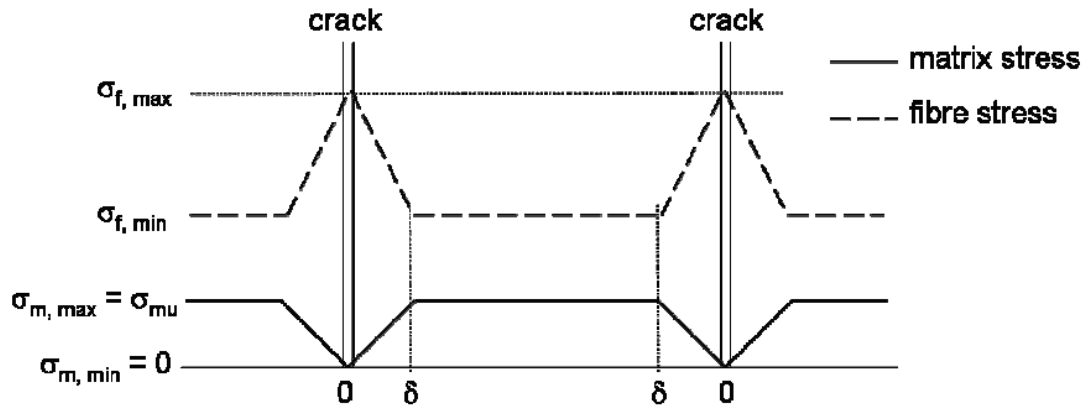
Figure 9 Stress distribution around a crack [Tysmans 2010]

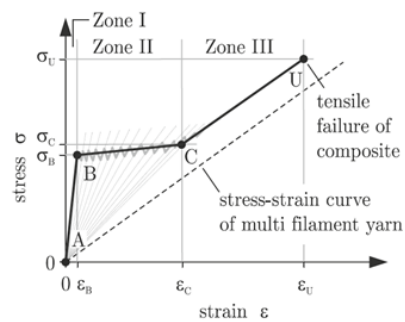
Figure 55 Degradation of the stiffness according the ACK theory [Butler 2010]

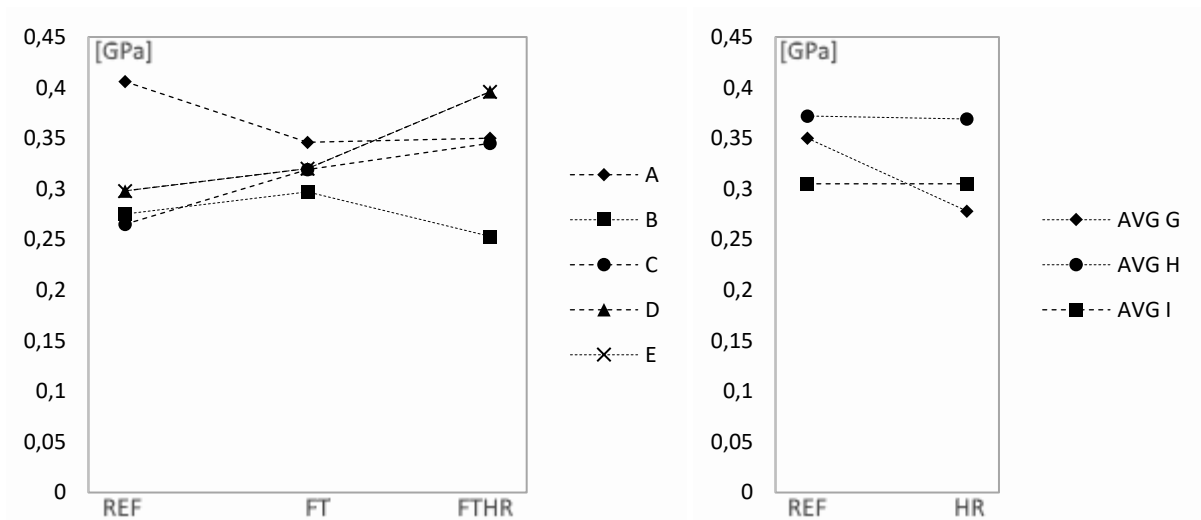
Figure 56 E modulus stage III

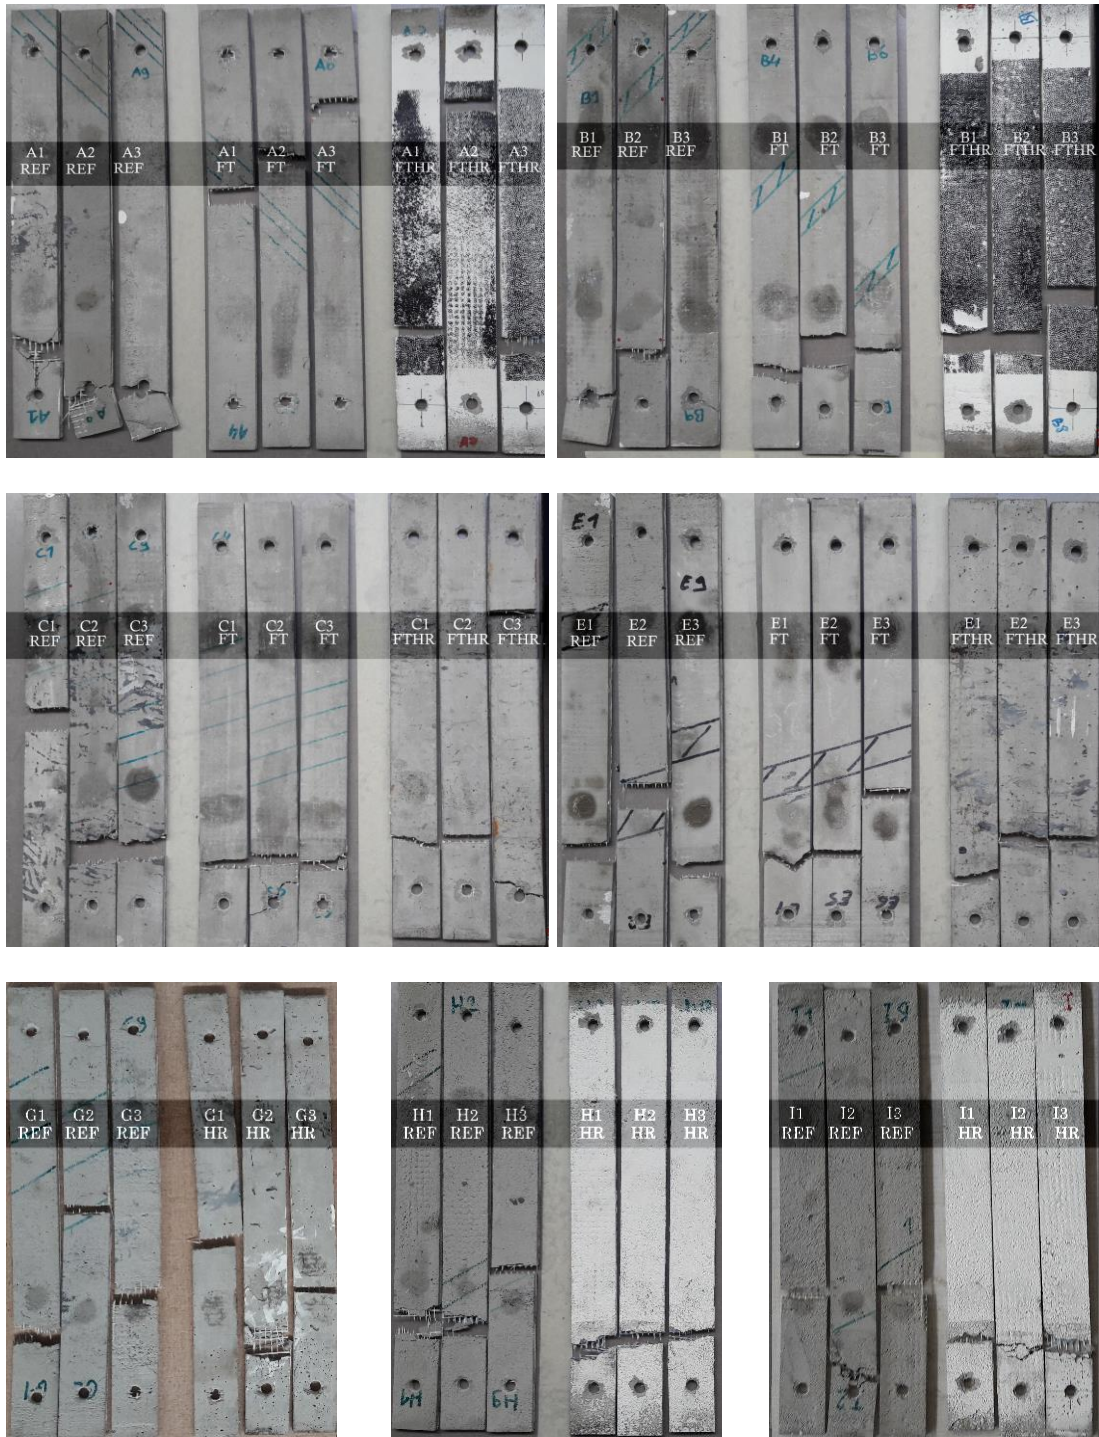
Figure B9 Failure mechanism of Series A, B, C, E, G, H and I
